Pre-purchase inspection report

Comprehensive inspection · 20 October 2026 · Ref INS-0042

Vehicle	**2018 Toyota HiLux SR5 Double Cab**	Registration	**SAMPLE QLD**
VIN	**MR0FZ29G0SAMPLE00**	Odometer	**142,350 km**
Colour	**Glacier White**	Inspected at	**Seller's driveway, Southport QLD**

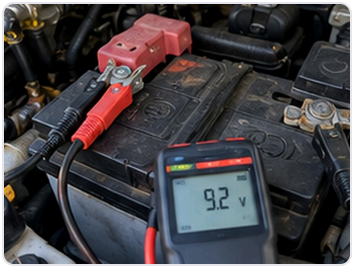
12V battery test

Battery failed the load test (cranking 9.2 V). Replace before purchase or negotiate the cost (approx. $250–$320 fitted).
